GalvinSafe[®] Pedestal Floor Mtd, Axion[®] MSR Eye/Face Wash Head, S/S Bowl, Hand & Foot Act, (HAWS)

Galvin Engineering: 190.82.11.90

HAWS: 7777-A + SP220SS

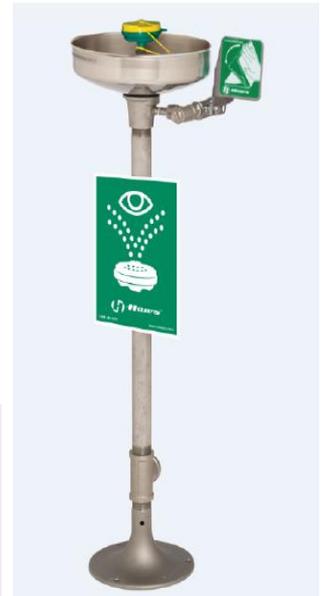
LOCATION OF UNIT: The Model 190.82.11.90 (7777-A) Stainless Steel combination Shower Eye/Face Wash should be installed in close proximity to potential accident areas. It should be clearly identified, free from obstructions and easy to access.

SUPPLY LINE: The minimum recommended line size is 1/2" BSP with 210 – 600 kPa flowing pressure. Where sediment or mineral content is a problem, an inlet filter is recommended.

PLUMBING CONNECTIONS: Inlet supply is female 1/2" BSPP. Waste outlet is male 1-1/4" BSPT.

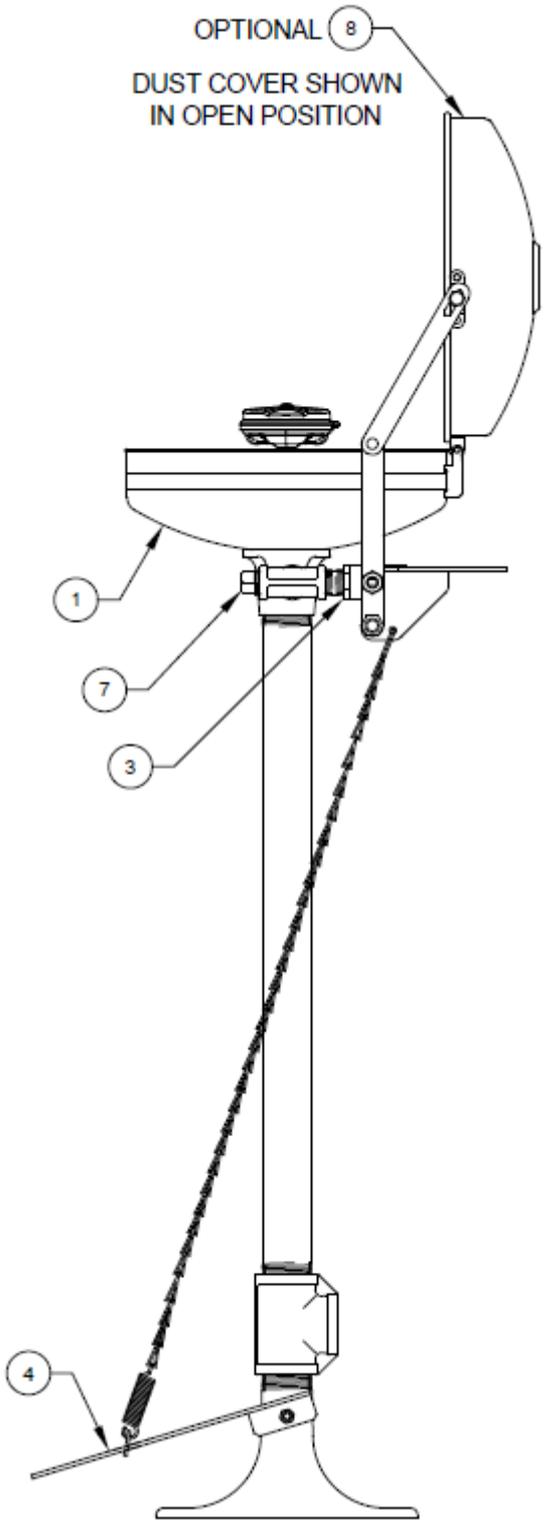
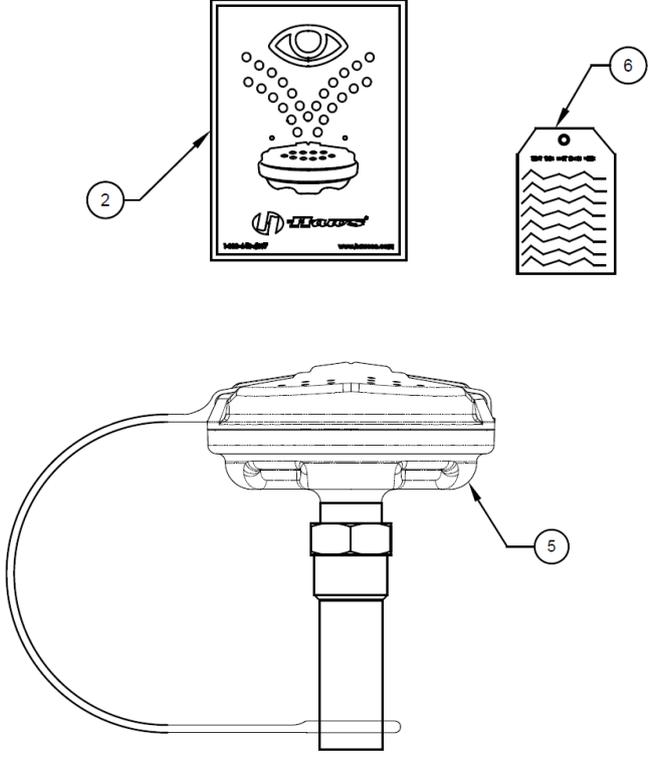
PARTS BREAKDOWN

EYE/FACE WASH ASSEMBLY

ITEM	ITEM CODE	DESCRIPTION
1	190.92.22.20	BOWL
2	190.91.12.32	EMERGENCY EYE SAFETY SIGN
3	190.92.41.30	VALVE ASSEMBLY
4	190.91.22.12	FOOT TREADLE
5	190.92.12.10	EYE/FACE WASH ASSEMBLY
6	190.91.80.33	TEST TAG
7	-	L-STRAINER*
8	-	SS DUST COVER ASSEMBLY* (OPTIONAL)

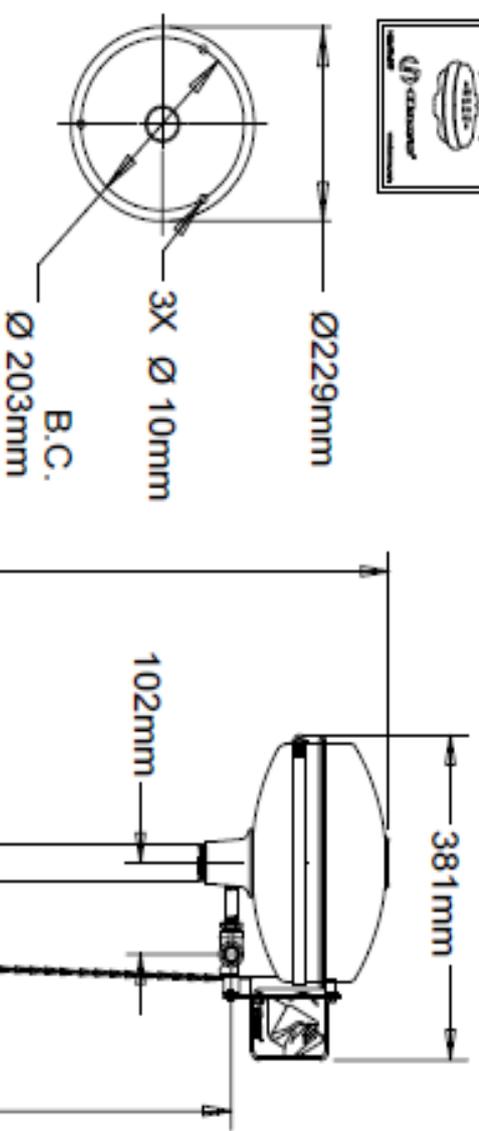
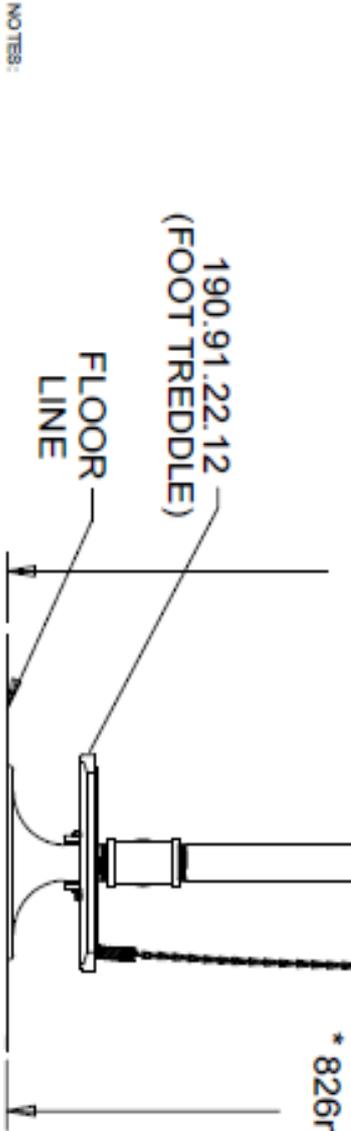
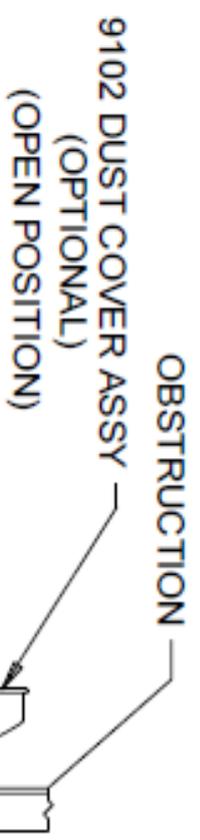
MOUNTING DETAIL

OBSTRUCTION

9102 DUST COVER ASSY (OPTIONAL) (OPEN POSITION)

35mm

[5] 981mm

L-STRAINER

1/2" BSPP(F) SUPPLY

[838mm - 1346mm] FLOW PATTERN

229mm

1-1/4" BSPT (M) WASTE

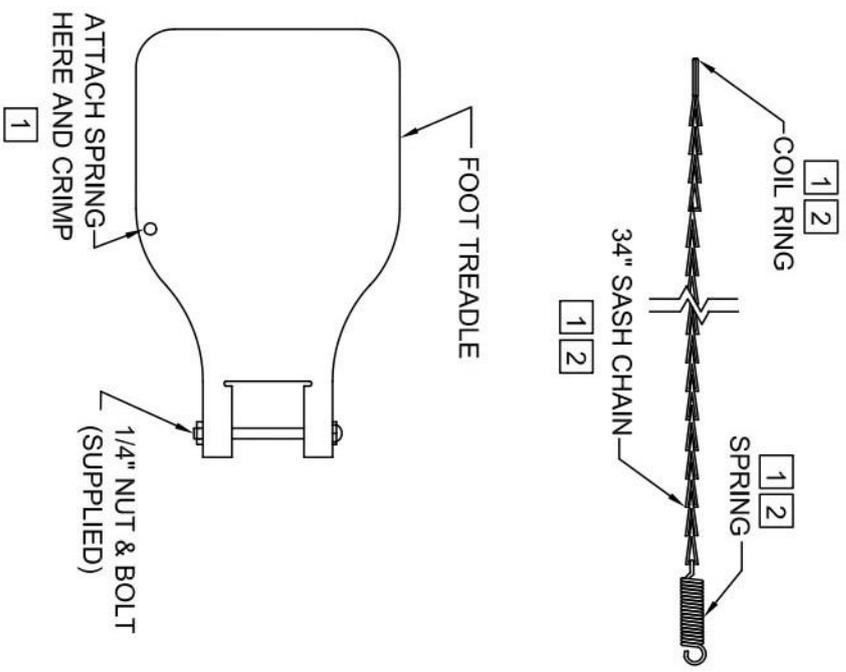
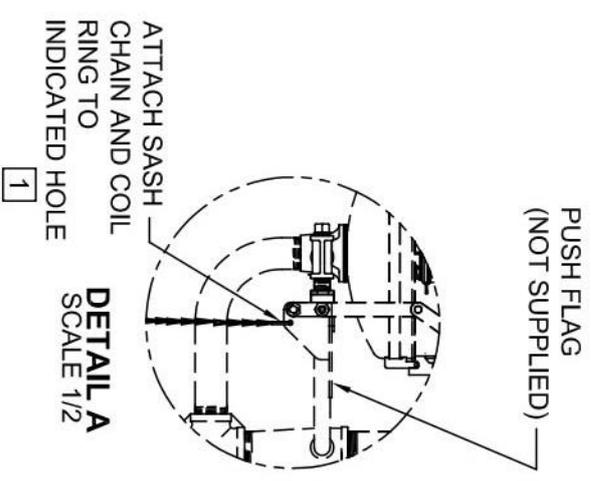
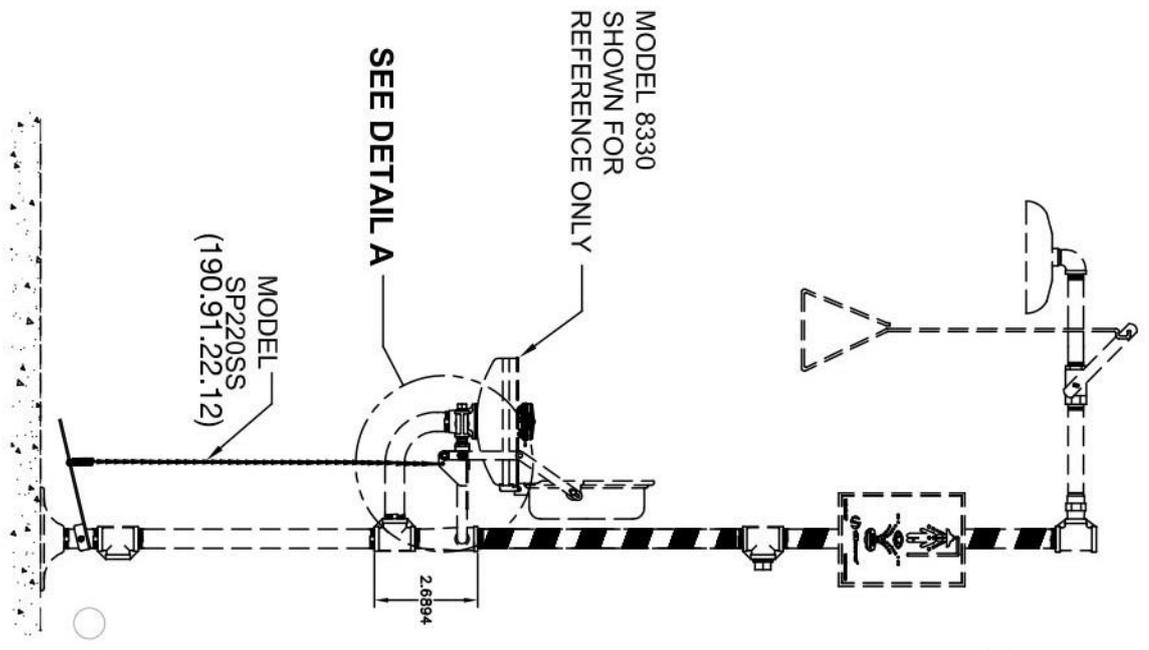
- 1 HOOK SPRING THROUGH ROUND OPENING OF TREADLE FROM TOP AND CRIMP SECURING IT TO THE TREADLE. AFTER ASSEMBLING FOOT TREADLE TO EYEWASH PEDESTAL, ATTACH COIL RING TO EXISTING PUSH FLAG THEN TRIM SASH CHAIN TO NECESSARY LENGTH IN ORDER TO PROVIDE NORMAL OPERATION OF EYEWASH.
- 2 CRIMP END OF SPRING TO SASH CHAIN.

Haws		1455 KLEPPE LANE	
SPARKS, NEVADA 89431		(775) 359-4712 FAX (775) 359-7424	
E-MAIL: HAWS@HAWSCCO.COM		WEBSITE: WWW.HAWSCCO.COM	
ECON NO. REVISED PER BY:	HM	MODEL(S)	SP220SS (190.91.22.12)
DRAWN: J. MAY	DATE: 03/07/00	CRKD:	TREADLE FOOT ASSY SS
APPROVED:	DATE:	SCALE: 1:5	DRAWING TYPE: INSTALLATION
PART NUMBER: 0002080393		SIZE: A	SHEET: 1 OF 1
DRAWING NO: 14558C00		REV: 1

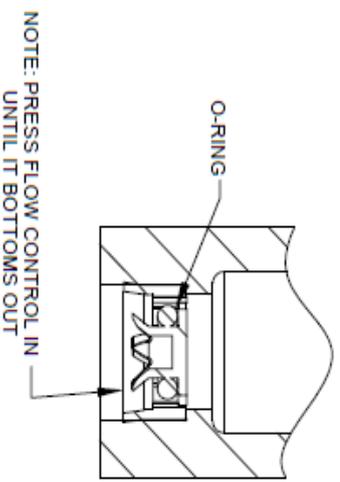
3 DETAIL A

NOTE: PRESS FLOW CONTROL IN UNTIL IT BOTTOMS OUT

FLOW CONTROL SHOWN IN PLACE

- 3 REMOVE EXISTING FLOW CONTROL FROM BASE BY PUSHING IT OUT FROM THE TOP, AND CAREFULLY REMOVE ANY DEBRIS LODGED BETWEEN O-RING AND HOUSING OR OPENINGS; ALSO, CHECK FOR ANY SEDIMENT OR MINERAL DEPOSITS BLOCKING OPENINGS. EXERCISE CAUTION NOT TO DAMAGE OR LOSE O-RING IN THE PROCESS. ALL OPENINGS ON FLOW CONTROL MUST BE FREE AND CLEAR OF ANY OBSTRUCTIONS FOR FLOW CONTROL TO FUNCTION PROPERLY. REINSTALL FLOW CONTROL. SEE DETAIL A FOR ORIENTATION.

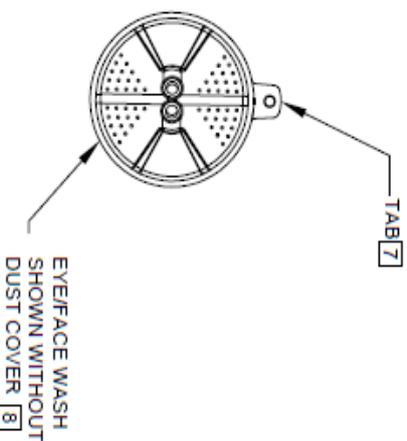
7 TAB

8 EYEFACE WASH SHOWN WITHOUT DUST COVER

- 7 REASSEMBLE 190.92.12.10 EYEFACE WASH ASSEMBLY ONTO ADAPTER (NOT SHOWN). ORIENT TAB TOWARDS THE BACK (AWAY FROM USER). DO NOT OVER-TIGHTEN.
- 8 PLACE DUST COVER (NOT SHOWN) ONTO EYEFACE WASH.

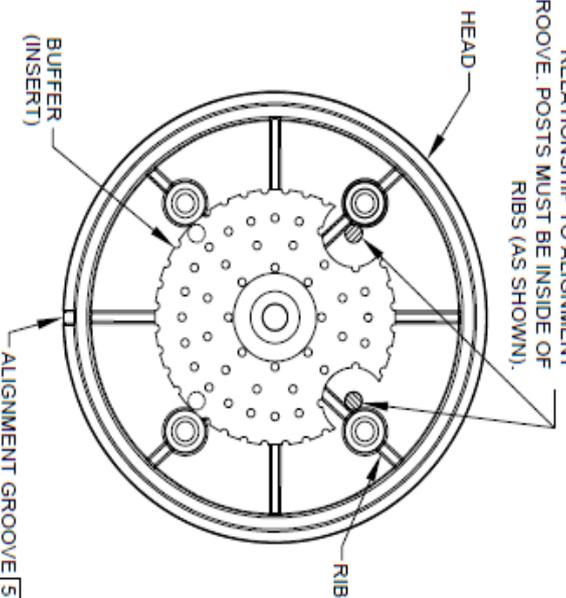
4 DETAIL B

NOTE ORIENTATION OF POSTS IN RELATIONSHIP TO ALIGNMENT GROOVE. POSTS MUST BE INSIDE OF RIBS (AS SHOWN).

- 4 INSERT BUFFER (INSERT) INTO EYEFACE WASH HEAD NOTING ORIENTATION OF POST IN RELATIONSHIP TO ALIGNMENT GROOVE AS SHOWN ON DETAIL B.
- 5 REASSEMBLE EYEFACE WASH HEAD, MAKING SURE THAT ALIGNMENT GROOVE ON EYEFACE WASH HEAD LINES UP WITH ALIGNMENT TAB ON BASE.
